# Manhole Inspection Summary

Manhole # S25M\_\_013MH

**Location** Address: **1300 Sargent Street**

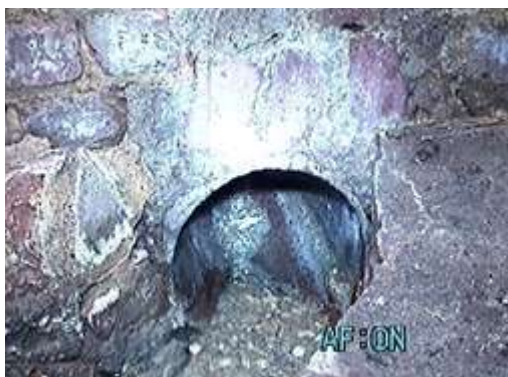
additional view of Pipe Out @ 12 O'clock

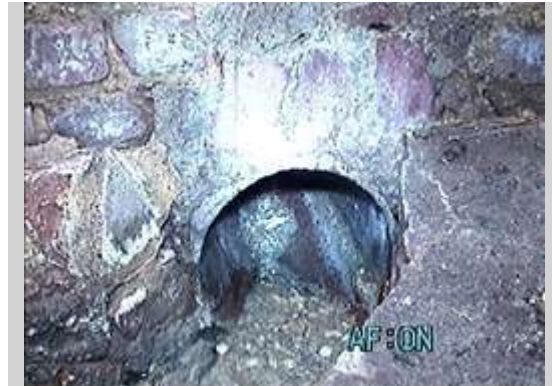
misc-1

Pipe Height: **8.4** (in.) Rod and Bar (Angled)  
Pipe Material: **Clay** ☐ Pipe Lined  
Invert Depth: **7.33** (ft.) Flow Characteristics: **Slow**  
Deposits: ☐ None ☐ Mud ☐ Sludge ☒ **Debris** ☐ Grease  
Silt Depth: **0.5** (in.) Deposits Extent: **Light**  
Infiltration: **None** Pipe Seal Cond: **Sound**
